Dairy Queen

5605 SE Division St.

Dairy Queen - Reconstruction

Application/Case No.18-210965-000-00-CO

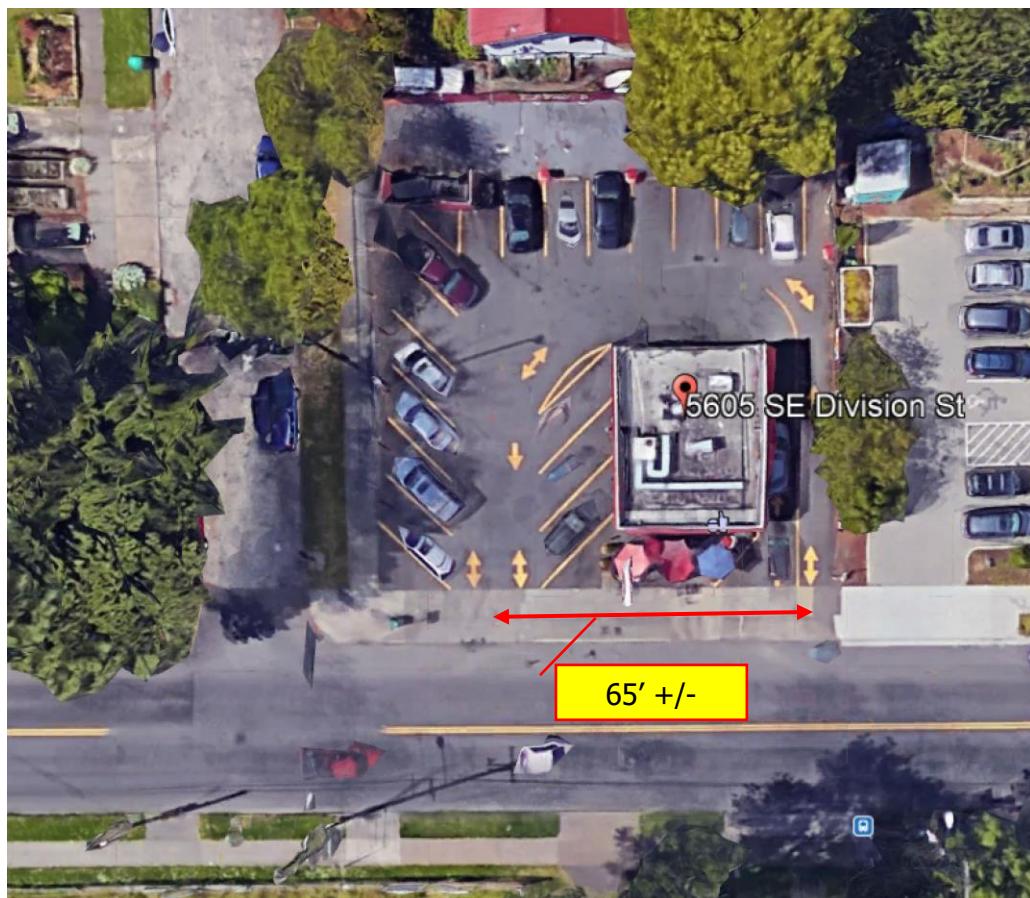
Figure 1 - Existing Site Plan

Under existing conditions, the Dairy Queen restaurant has a walk-up window and a drive through window with one car length capacity. In addition, there are two full access points to SE Division Street, spaced approximately 65 feet apart (See Figure 1-Existing Site Plan).

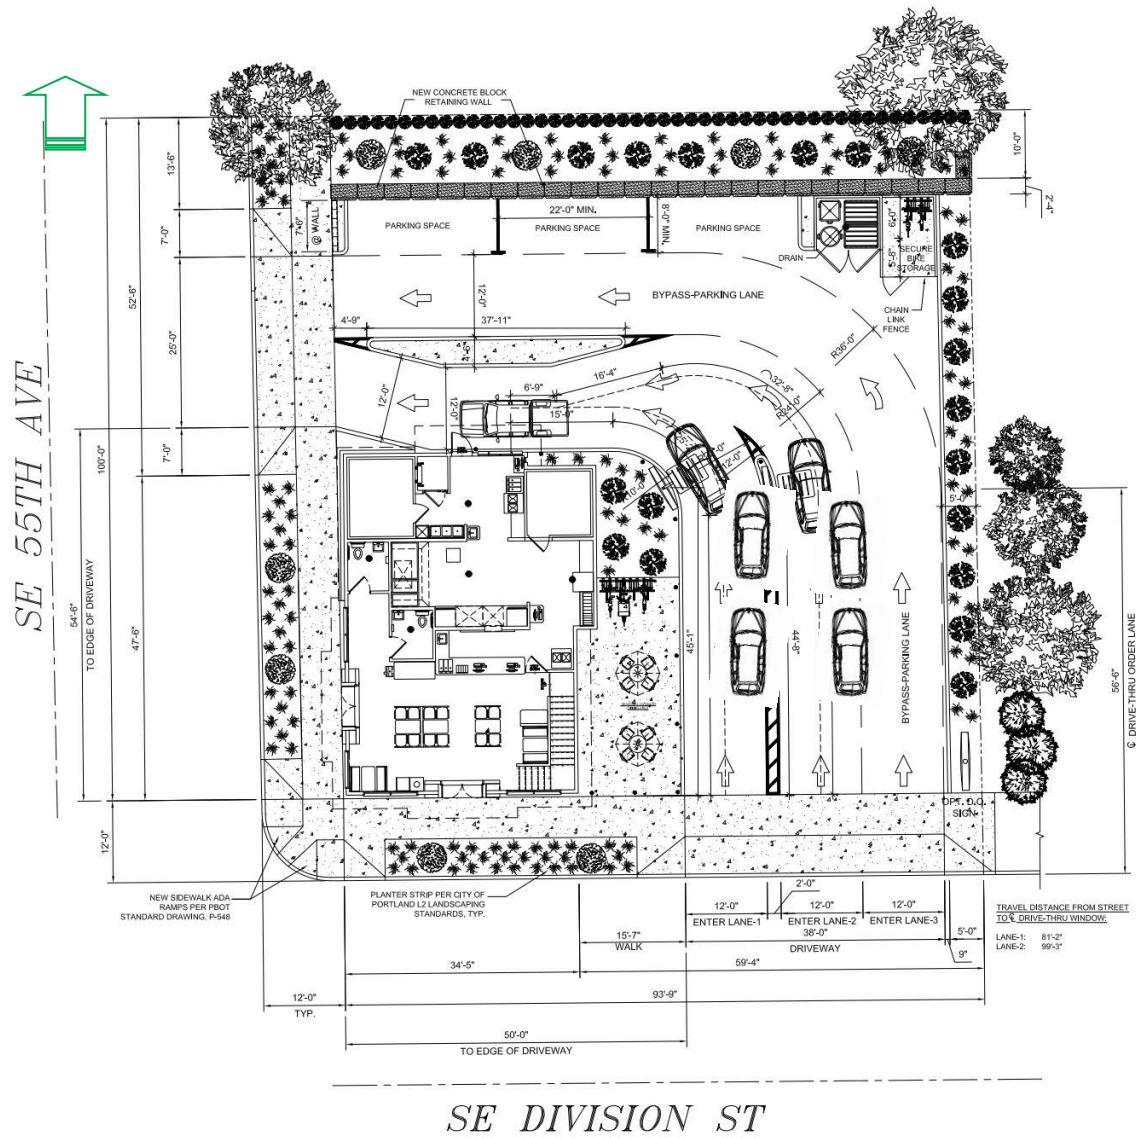
Figure 2- Site Layout

This focused summary report is prepared in support of the applicant's request for reconstruction of a Dairy Queen restaurant located at 5605 SE Division Street in Portland with improved on-site queue storage length and modified site access points which better complies with the City of Portland access spacing standards (See Figure 2-Site Layout).

The new Dairy Queen Restaurant will replace the existing building by reconstructing a new 1,791 SF building (2 stories), an extended and double queue lanes, allowing a combined queue length of at least 85 feet which will accommodate 6 average length vehicles comfortably as well as a queue bypass through lane entering from SE Division street and exiting on SE 55th Avenue.

In addition, after placing their order at the drive-up window the vehicles will exit on SE 55th Avenue. The increased queue length as well as eliminating one of two full accesses on SE Division to one "enter only" and one exit only access on SE 55th Avenue, will enhance site circulation, site access and queue length significantly. The enhancement is in line with City of Portland recommendations and highly desired.

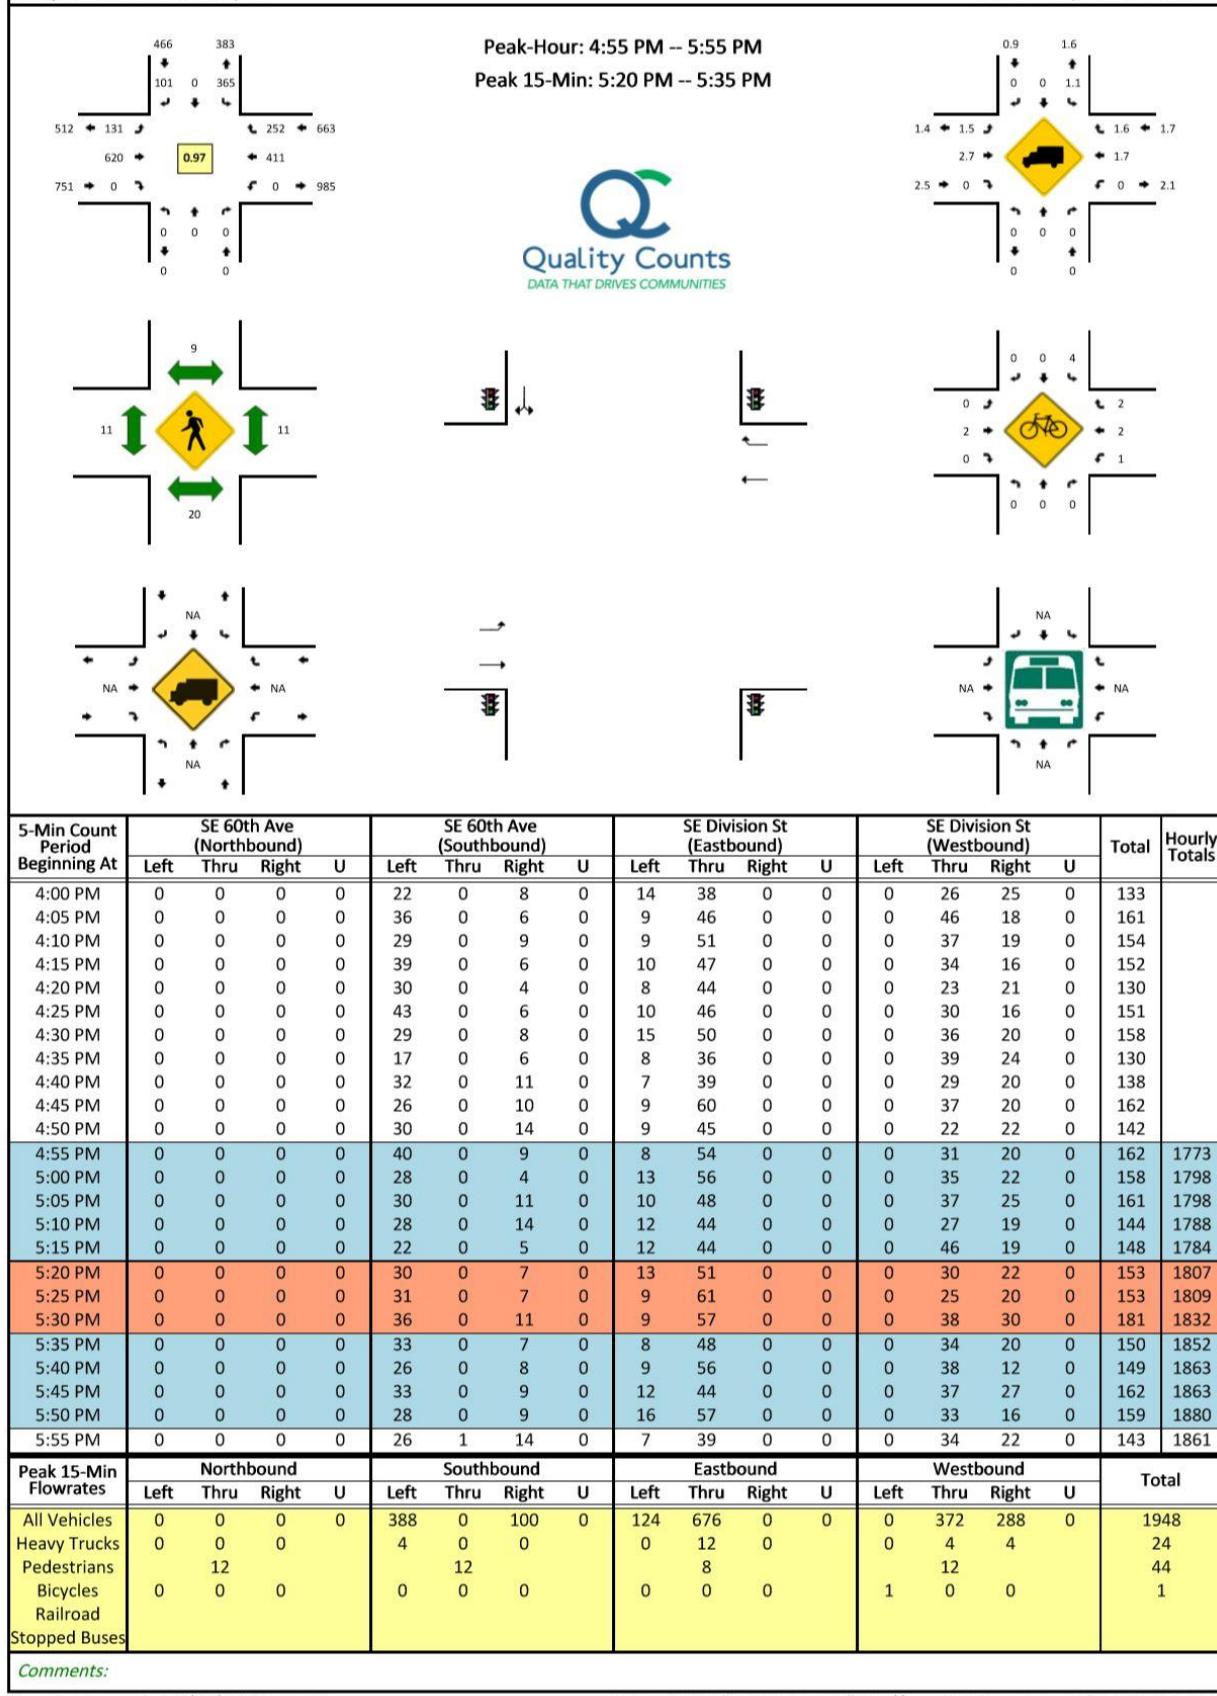
LOCATION: SE 60th Ave -- SE Division St
CITY/STATE: Multnomah, OR

QC JOB #: 14885802
DATE: Thu, Jan 17 2019

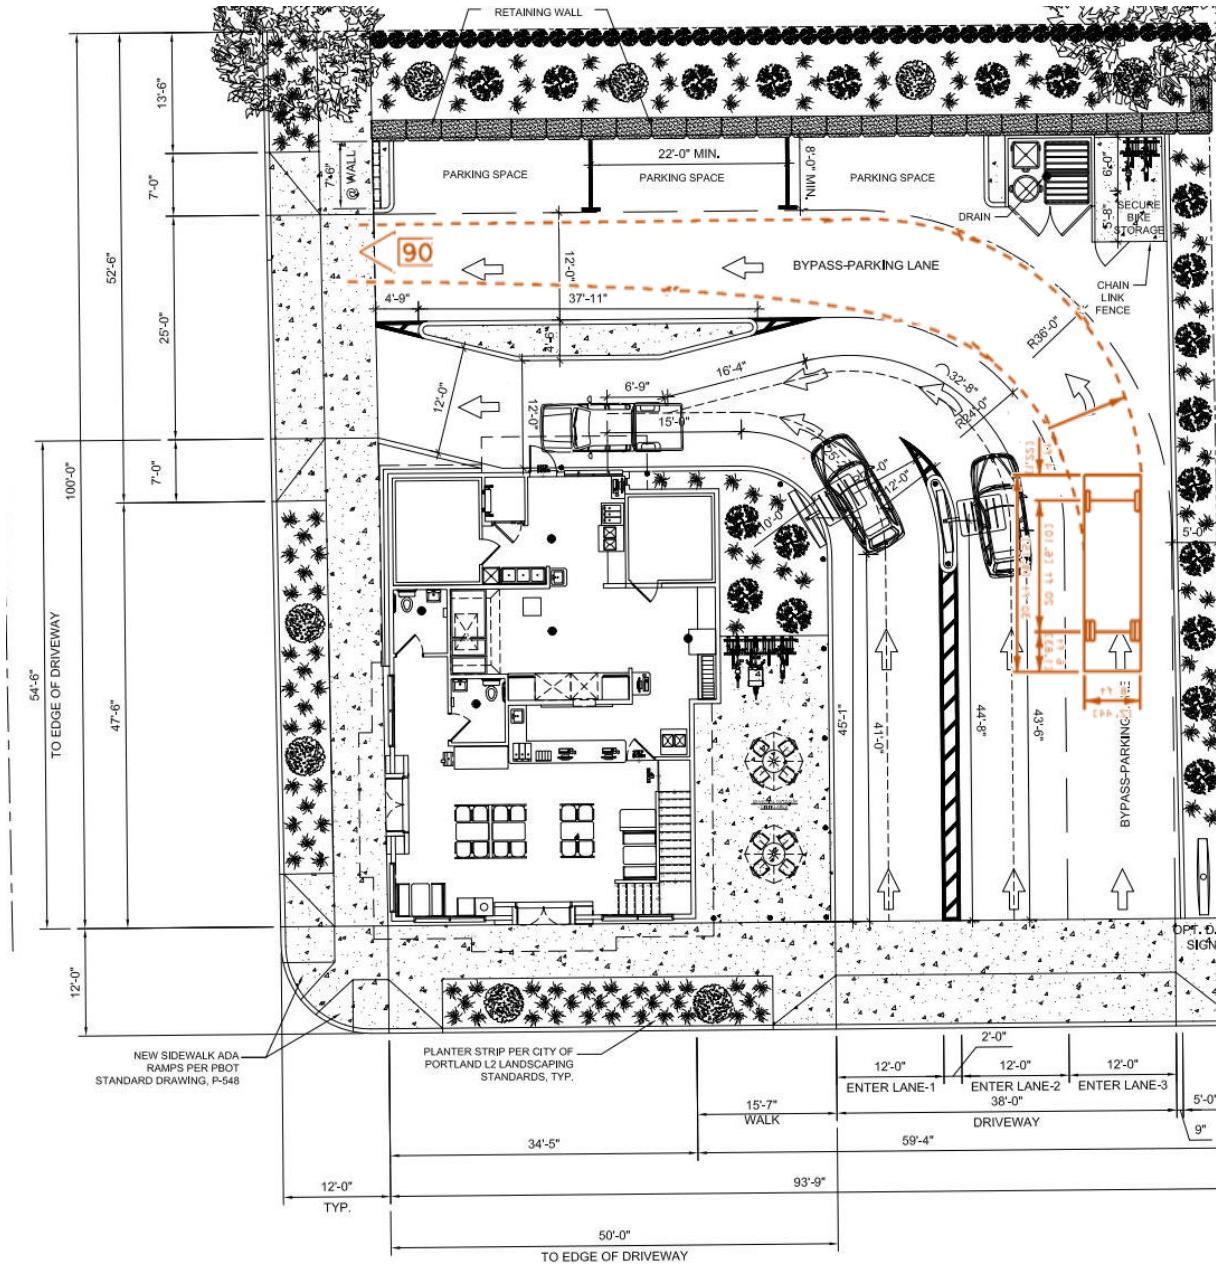
Turning Radii Review

SE DIVISION ST
